# ***Appendix B***

## ***Communities***

**Purpose**

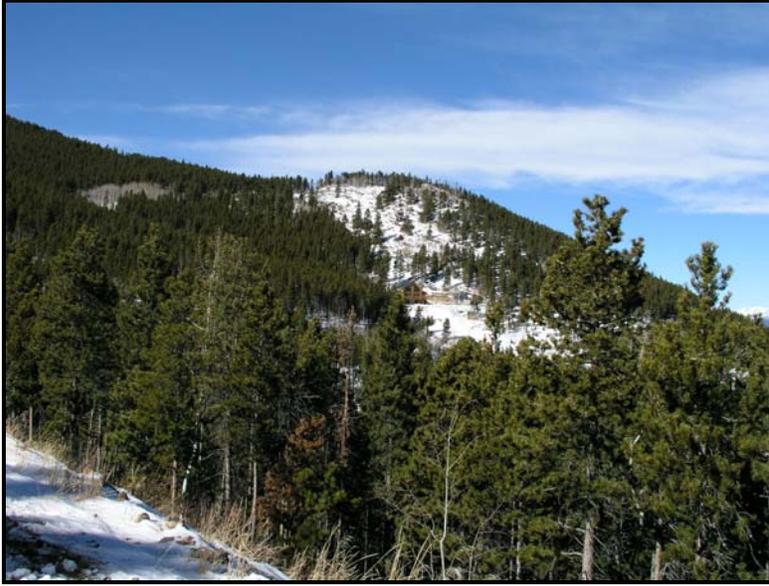
Figure 4

<b>Hazard Rating:</b>	<b>Extreme</b>
<b>Does the neighborhood have dual access roads?</b>	No
<b>Are there road grades <math>\geq 10\%</math>?</b>	Yes
<b>Are all access roads of adequate width?</b>	No
<b>Average lot size:</b>	>5 Acres
<b>Fuel models found in the neighborhood:</b>	8, 10
<b>Water supply:</b>	None
<b>Hazards:</b>	Steep slopes, inadequate access roads, natural chimneys, ravines, no water supply, and homes in saddles.

Although the two main roads in this community are generally of adequate width, they are dead ends with few turnarounds. Some driveways are quite long and are steep, narrow and rocky. Access and egress would be difficult in fire conditions. Homes are built mid-slope, some in saddles and above ravines, on slopes of up to 60%. The area has heavy loads of FM 8. There are many dense stands of decadent lodgepole pine. The dominant construction type is mostly newer homes on large lots, but most are poorly mitigated. Most homes have no or inadequate addressing. Some yards are in need of clean up. Low structure density is the only bright spot in this community and that is likely to change.

Reduce ladder fuels and thin the slopes below homes. Improve roads, address signage, and turnarounds. Improvement in the water supply is critical (see Water Supply FMZ). Most homes need defensible space. Extended defensible spaces and adequate shelter-in-place areas or safety zones are highly recommended. A parcel level analysis of this neighborhood is recommended.

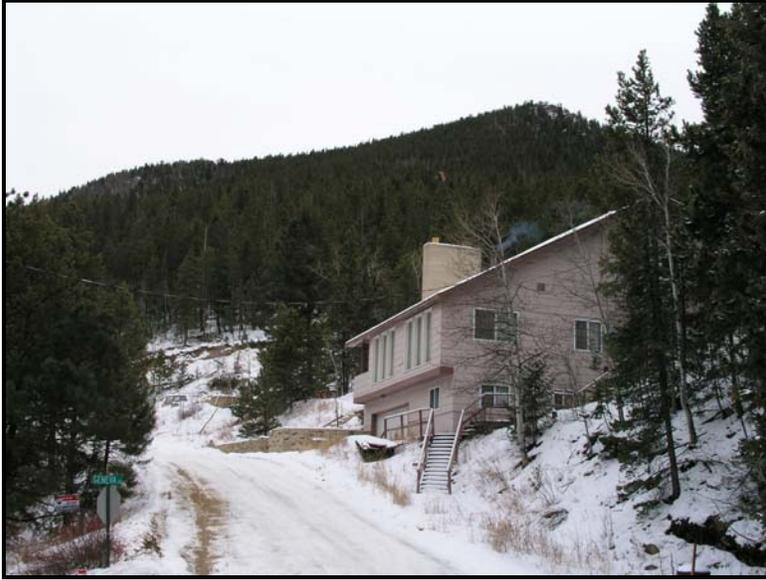
Figure 5

<b>Hazard Rating:</b>	<b>Extreme</b>
<b>Does the neighborhood have dual access roads?</b>	Yes
<b>Are there road grades <math>\geq 10\%</math>?</b>	Yes
<b>Are all access roads of adequate width?</b>	No
<b>Average lot size:</b>	<1 Acre
<b>Fuel models found in the neighborhood:</b>	8, 10
<b>Water supply:</b>	None
<b>Hazards:</b>	Ravines, inadequate access roads, no water supply.

Although the access along Drew Hill and Ralston Creek Road is good, there are many homes built up steep side roads and driveways. Even along Ralston Creek Road, some homes would be difficult to access because of heavy vegetation growing right up to the structures, cluttered yards, narrow driveways and difficult or absent turnarounds. There are missing or inadequate street signs and addressing throughout the area. Many homes are built mid-slope or at the top of steep slopes. North facing slopes average 25% and south aspects reach 40%. There is a heavy fuel load and a continuous canopy with plentiful ladder fuels. Most of the construction in the area consists of older wooden homes. Firewood stacks and other manmade fuel jackpots are common near structures. There are many parcels with tree limbs touching the structures. The nearest water supply is draft water from ranch ponds in Golden Gate State Park, about 1.5 miles away.

Thin conifers and reduce ladder fuels on slopes below homes. Clean up dead and down material. Add reflective street and address signage. Thin trees along roadways. Improve driveways and turnarounds. If it is not possible to create additional escape routes, consider developing shelter-in-place areas or safety zones. Extended defensible space should be considered for homes located mid-slope. Clean up flammable yard clutter. Cisterns should be added especially for homes that are not close to Crawford Gulch Road. Most homes in this area need defensible space. A parcel level analysis of this neighborhood is recommended.

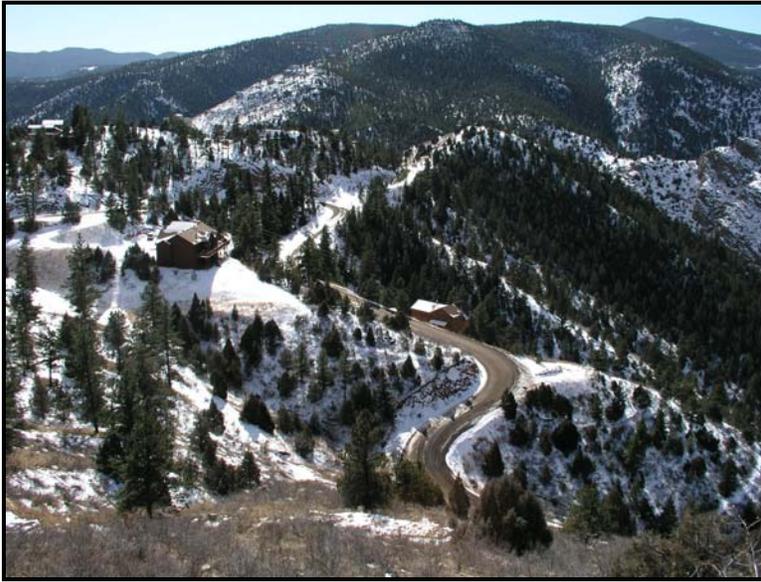
Figure 6

<b>Hazard Rating:</b>	<b>Extreme</b>
<b>Does the neighborhood have dual access roads?</b>	Yes
<b>Are there road grades <math>\geq 10\%</math>?</b>	Yes
<b>Are all access roads of adequate width?</b>	No
<b>Average lot size:</b>	1-5 Acres
<b>Fuel models found in the neighborhood:</b>	2, 6, 9, 10
<b>Water supply:</b>	None
<b>Hazards:</b>	Ravines, natural chimneys, homes in saddles, steep roads and no water supply.

This community is built along both sides of a predominately north/south side canyon that connects Robinson Hill with Clear Creek Canyon. The north and west facing slopes of this steep canyon have high fuel loads of mixed conifers. Most homes do not have addressing that is visible from the road. The most common construction type is wood siding with asphalt roofs. Although fuel loads are moderate at the top of the canyon (FM2) there are heavy fuel loads of mostly FM 9 and 10 around and below homes. Most homes are built at the top and middle of steep slopes, many at the top of natural chimneys and other hazardous terrain features. Secondary roads and driveways are steep and many homes have inadequate turnarounds. All of the roads except Douglas Mountain Road appear to be dead ends.

This area desperately needs cisterns. Tender relays from the nearest water supply would be slow and easily cut-off. Landscape scale fuel breaks would be hard to construct here due to the steepness of the terrain. Extended d-spaces and thinning below homes is highly recommended. Thinning in the gullies below Douglas Mountain road is needed to protect the access. Most homes need defensible space. Shelter-in-place tactics should be considered in this area due to easily threatened access. Improved turnarounds should be considered at residences and on secondary roads. Most homes need reflective addressing that is visible from the road. A parcel level assessment is recommended for this community

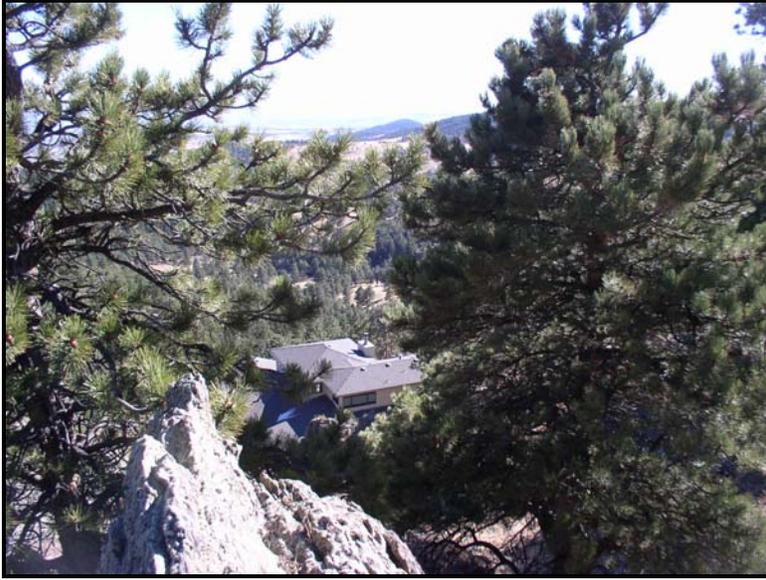
**Figure 7**

<b>Hazard Rating:</b>	<b>Very High</b>
<b>Does the neighborhood have dual access roads?</b>	No
<b>Are there road grades <math>\geq 10\%</math>?</b>	Yes
<b>Are all access roads of adequate width?</b>	Yes
<b>Average lot size:</b>	>5 Acres
<b>Fuel models found in the neighborhood:</b>	1, 2, 9, 10
<b>Water supply:</b>	10,000 gal. cistern on Misty Road
<b>Hazards:</b>	Steep slopes, natural chimneys, ravines, steep narrow driveways, inadequate water supply.

This exclusive neighborhood consists of large recently constructed homes on large lots. Most homes have ignition resistant roofs and some have ignition resistant external walls. There are many homes built at the top of steep ravines, some over 40% slope, with heavy loads of dog-hair lodgepole pine and Douglas-fir (FM 9 & 10) especially on the north end of Homestead Road. Misty and Homestead Roads, which are the primary access, are steep but of adequate width. Turnarounds are few and many driveways have tight switchbacks, are steep, narrow and overgrown with fuels. Easily cut off single access, heavy fuels, inadequate water supply and high values-at-risk combine to make this a very hazardous area.

There is one 10,000 gallon cistern for this entire area and it does not appear on the GGFDF list of water sources. This cistern needs to be marked, mapped and access to it improved. This rapidly growing area needs more cisterns, as ponds do not seem to be reliable or easily accessed. Misty and Homestead Roads need thinning to at least a 300' width to protect access and egress. Many homes need defensible spaces, and extended defensible spaces should be considered for homes located above ravines with hazardous fuel loads. The maintenance of a safety zone meadow by irrigation or mowing should be considered. A parcel level analysis of this neighborhood was conducted in 2002. An extensive shaded fuel break is being implemented in the fall of 2004 as a result of the findings of the 2002 study.

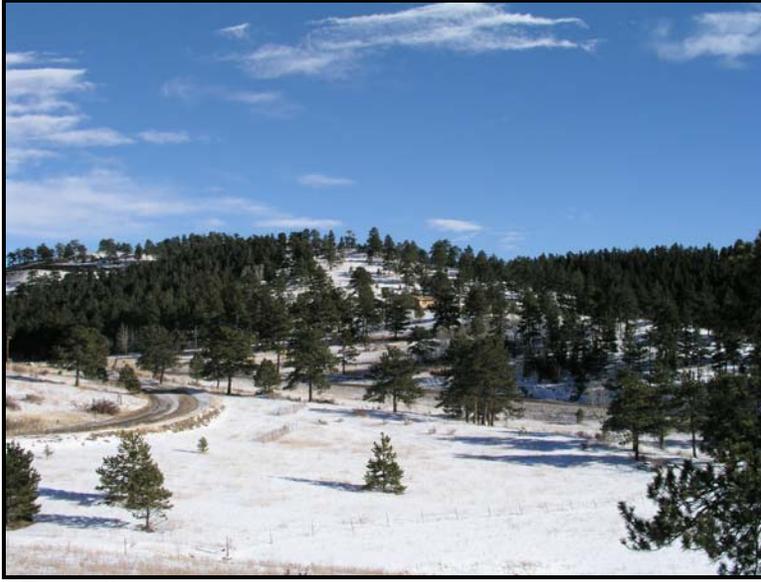
Figure 8

<b>Hazard Rating:</b>	<b>High</b>
<b>Does the neighborhood have dual access roads?</b>	No
<b>Are there road grades <math>\geq 10\%</math>?</b>	Yes
<b>Are all access roads of adequate width?</b>	No
<b>Average lot size:</b>	1-5 Acres
<b>Fuel models found in the neighborhood:</b>	1, 2, 9, 10
<b>Water supply:</b>	Cisterns on both sides of Douglas Mountain Road.
<b>Hazards:</b>	Steep draws, ravines.

Homes in this area are built on both sides of the wide canyon bottom that runs southwest from the intersection of Robinson Hill Road and Douglas Mountain Road and up steep side roads mainly on the northwest side of Douglas Mountain Road. Slopes below homes are generally not as steep as in Douglas Mountain-South, averaging 15-25%. The majority of the east side of Douglas Mountain Road consists of ranches located in fuel models 1 and 2. Development throughout this community consists of widely scattered clusters of homes varying from older ranch homes to recent construction with ignition resistant roofs. Most homes have wood siding, and in the area west of Douglas Mountain Road the majority are located above heavy loads of fuel models 9 and 10. Addressing is better in this area than most of the district, but many homes need defensible spaces.

Fuels reduction and slash removal should be done downhill of homes and along access road, especially in the northwest portion of this community. Most homes need defensible space and some need yard cleanup. Since there is a single access to the homes in the western area, the development of shelter-in-place areas and/or safety zones is strongly recommended. Although Douglas Mountain Road has adequate fuels clearance, fuels reduction is a critical need on side roads and driveways. A parcel level analysis is recommended.

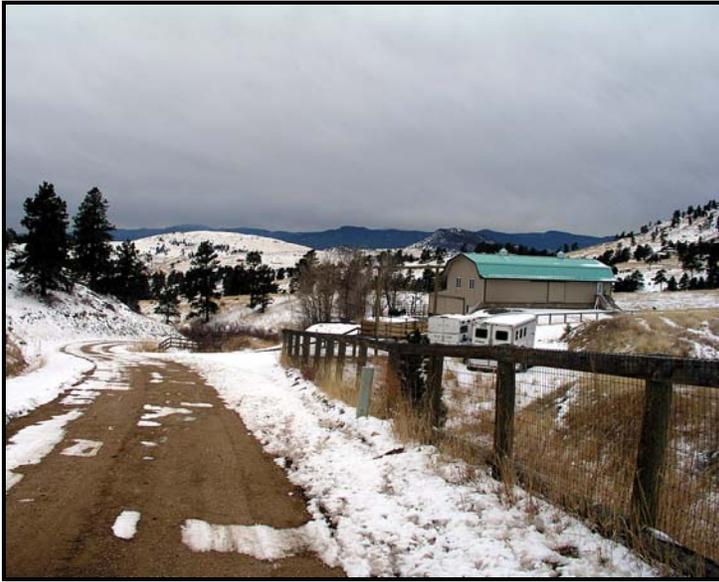
Figure 9

<b>Hazard Rating:</b>	<b>High</b>
<b>Does the neighborhood have dual access roads?</b>	No
<b>Are there road grades <math>\geq</math> 10%?</b>	Yes
<b>Are all access roads of adequate width?</b>	Yes
<b>Average lot size:</b>	>5 Acres
<b>Fuel models found in the neighborhood:</b>	2
<b>Water supply:</b>	Draft water from stock ponds (not reliable)
<b>Hazards:</b>	Ravines, inadequate roads and no water supply

Fuels are mostly moderate loadings of FM1 and FM2. Although most roads are of adequate width, some driveways and private roads are very steep and narrow. Residences are mostly ranch houses, many older, on large, widely spaced lots. Some homes have combustible materials near structures and propane tanks. On Mica Mountain Road a noticeable quantity of ponderosa pine has been cut and the slash left or piled at the side of the road. Many homes need defensible space and yard cleanup.

Eliminate standing dead, and remove red needle slash from old cuttings. Clear grasses and combustible materials away from structures and propane tanks. A reliable water supply is critical for this area. At least two large (10,000 gallon or larger) community cisterns are recommended. Reflective address signage is needed for most homes and driveways. Yard clean up for most homes is recommended. A parcel level analysis is recommended.

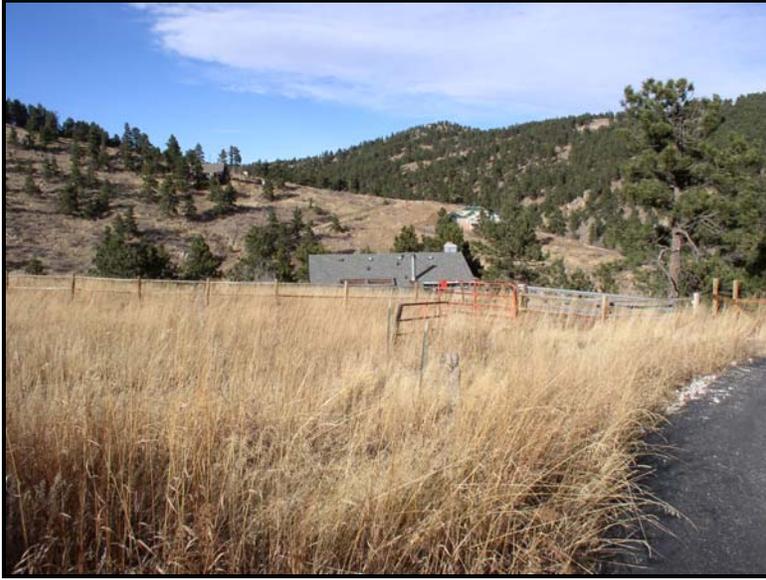
Figure 10

High

Ravines, inadequate roads

Most homes in this community are built on ridge tops or on the upper 1/3 of the slopes above both sides of the canyon bottom. Although FM 1 and 2 dominate, in some areas the fuel bed depth of grasses is almost enough to qualify as FM 3. Addressing is very confusing with random numbers appearing at a major fork in the road. There are at least two different numbering schemes present and many properties have no address signage. Some homes are located up steep driveways and private roads, many with locked gates. There are some low power lines in this area that may prevent the use of larger apparatus. In the western part of the community homes become more spread out along very long driveways with few turnouts. This area can be escaped to the west by using private ranch roads.

Addressing needs to be straightened out. Confusing signs should be replaced with reflective markers showing clear directions. More cisterns are needed especially in the western area. Stock ponds should be investigated for landowner cooperation and possible dry hydrant installations. Homes need defensible space and mowing. Extended defensible spaces, especially for homes on the north side of the canyon, are recommended. A parcel level analysis is recommended.

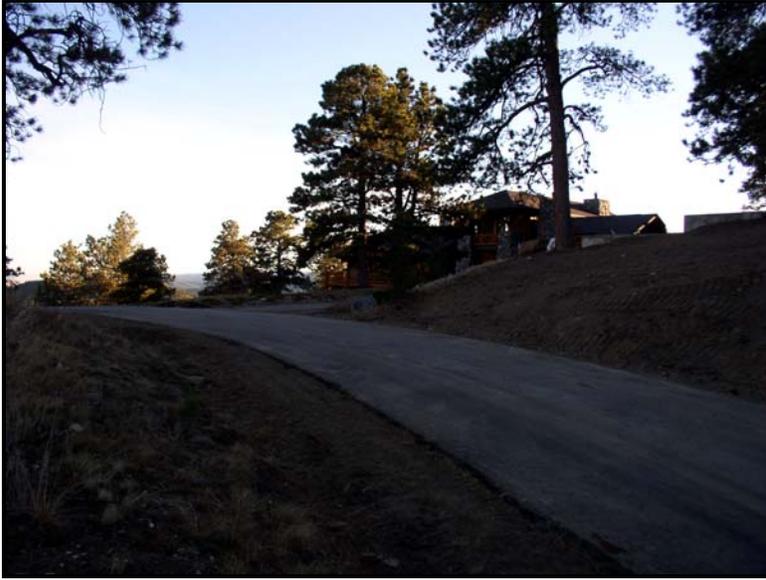
Figure 11

<b>Hazard Rating:</b>	<b>High</b>
<b>Does the neighborhood have dual access roads?</b>	No
<b>Are there road grades <math>\geq 10\%</math>?</b>	No
<b>Are all access roads of adequate width?</b>	Yes
<b>Average lot size:</b>	1-5 Acres
<b>Fuel models found in the neighborhood:</b>	2
<b>Water supply:</b>	Cisterns (7,000 to 30,000 gallons)
<b>Hazards:</b>	Houses on ridge tops, steep slopes, ravines

This area has had some mitigation. Limbing and thinning near homes is apparent, however this small community of luxury homes is located at the top of a ridge. Fuels in the community are mostly FM2, but the slopes below some homes have heavy FM 9 especially in ravines. There is no reflective address signage in this community. There is only one way in and out of this gated community. Access roads are paved and of adequate width, but turnarounds that are adequate for fire apparatus are scarce. There is a 30,000 gallon cistern at the entrance to this community that does not have a fire department connection and is therefore useless for fire suppression.

Even though there is a 7,000 gallon and an 8,000 gallon cistern across Belcher Hill Road from this area, the 30,000 gallon cistern should be considered the primary water supply for this community and must be fitted with a proper FDC. Fuels should be thinned on slopes below homes. Extended defensible spaces should be considered for homes directly above hazardous slopes. All homes need reflective addressing. A parcel level analysis is recommended.

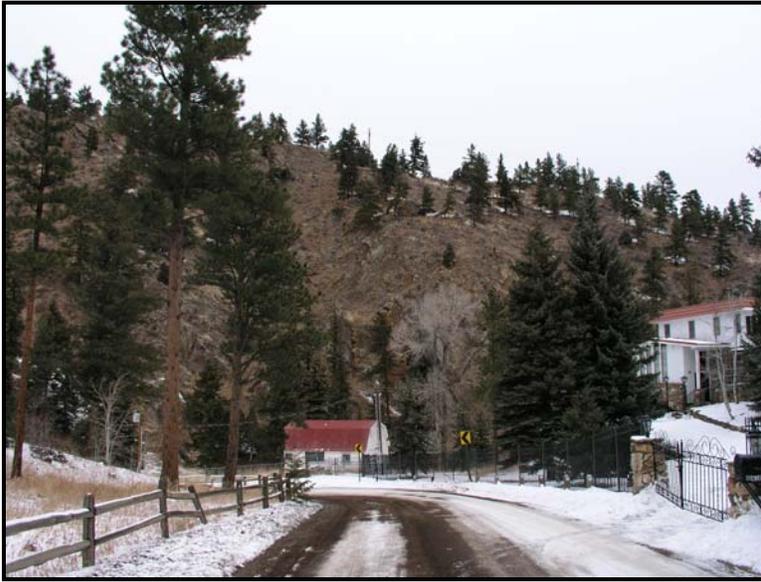
Figure 12

<b>Hazard Rating:</b>	<b>High</b>
<b>Does the neighborhood have dual access roads?</b>	Yes
<b>Are there road grades <math>\geq</math> 10%?</b>	Yes
<b>Are all access roads of adequate width?</b>	No
<b>Average lot size:</b>	>5 Acres
<b>Fuel models found in the neighborhood:</b>	2, 9, 10
<b>Water supply:</b>	Possible draft water from stock ponds (all are hard to get to).
<b>Hazards:</b>	Ravines, inadequate access roads and no water supply

This area is characterized by scattered homes on large lots. Many are located away from Drew Hill Road, the primary access, on long narrow driveways with no or poor turnarounds. The topography in this area is quite steep and there is an appreciable quantity of dog-hair stands of lodgepole pine and mixed conifer (FM 9). Some homes in this area are located at the top of steep slopes of FM 9 and 10. The 477 acre Spirit Mountain Ranch at the south end of this area could become a major development.

Most homes need extended defensible space because of heavy fuels. As with all structures located in the canyon bottoms ignition resistant roofs are highly recommended to prevent ignitions from ember cast and rolling materials. Address signage needs improvement. Individual cisterns may be the best choice for water supply needs in this area, although one or two large (10,000 -30,000 gallon) cisterns would be advisable for Spirit Mountain Ranch depending on what the final structure density is. A parcel level analysis is recommended.

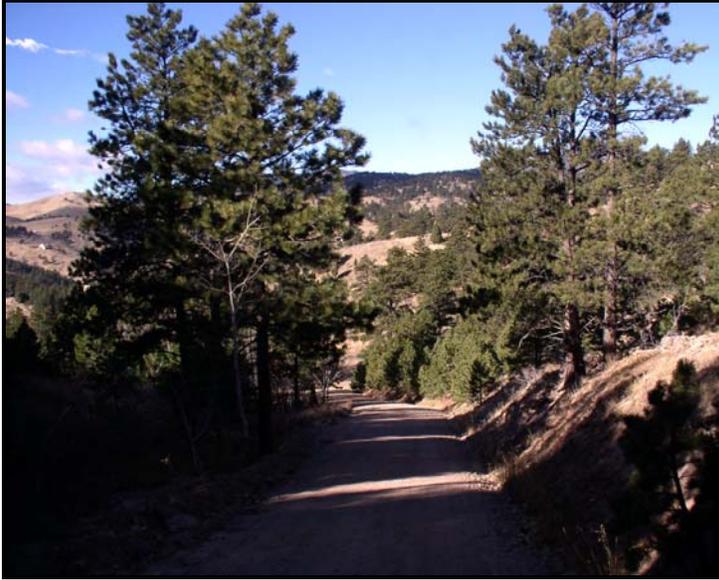
Figure 13

<b>Hazard Rating:</b>	High
<b>Does the neighborhood have dual access roads?</b>	No
<b>Are there road grades <math>\geq 10\%</math>?</b>	Yes
<b>Are all access roads of adequate width?</b>	Yes
<b>Average lot size:</b>	>5 Acres
<b>Fuel models found in the neighborhood:</b>	1, 2, 9, 10
<b>Water supply:</b>	None
<b>Hazards:</b>	Steep narrow roads, ravines, no water supply

This neighborhood has steep roads with few turnarounds. There are heavy surface loads of FM 2 (ponderosa pine with grass understory) in this area, with some FM 9 and 10 (mostly fir, aspen and juniper) in north facing drainages. The primary access road has a 15% grade and there are driveways in this area that go up 25% slopes. The primary access is of sufficient width but there are no turnarounds until the road reaches the plateau. Address markers are missing or inadequate for most homes. There is a low power line near the county shops that may prevent the access of larger apparatus. The Grange building may make a good evacuation center. Heavy equipment and fuel are available next door at the county shops.

Access roads need fuel reduction. Homes are spread out enough so that individual cisterns may be the best solution to the water supply problem. Add reflective address signage. Mow grasses away from structures. Develop shelter-in-place areas and/or safety zones. Most homes need defensible spaces. A parcel level analysis is recommended.

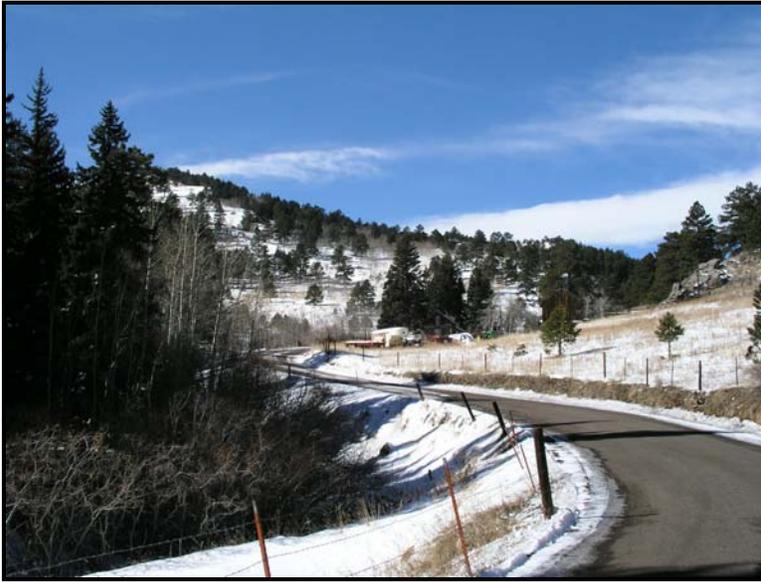
Figure 14

<b>Hazard Rating:</b>	High
<b>Does the neighborhood have dual access roads?</b>	Yes
<b>Are there road grades <math>\geq 10\%</math>?</b>	No
<b>Are all access roads of adequate width?</b>	No
<b>Average lot size:</b>	>5 Acre
<b>Fuel models found in the neighborhood:</b>	1, 2, 9, 10
<b>Water supply:</b>	Cisterns of various sizes (at least 3 sites)
<b>Hazards:</b>	Ravines, inadequate access roads, cluttered yards,

The area, which is to the west of Douglas Mountain Road, is quite different than the eastern side of Robinson Hill. Homes here are built along a mainly east/west running canyon bottom with slopes of 20% to 40% above homes. Most homes are located mid-slope. Many have long, narrow, steep driveways with tight switchbacks. Many of the buildings in this area are older wood siding construction, some with wooden roofs. There are historic ranch buildings in this community. Primary fuels in this area are moderate loads of FM 2 broken by grassy meadows (FM 1) with some patches of FM 9, mostly in north facing drainages. There is more insect mortality in this area than in other GGFPD communities. Combustible yard clutter also makes the fuel loading more hazardous in this area. At Raptor Point, Robinson Hill Road becomes Road 8, which provides an escape route into Gilpin County. This road is narrow and winding with very few turnarounds.

Most homes in this area have reflective addressing and street signage is good. Many driveways and private roads need fuels reduction. Any improvements in road widths and turnarounds that are possible should be considered. Standing dead trees should be thinned and dead and down materials cleaned up. Many yards need clean up and most homes need defensible space. A parcel level analysis is recommended.

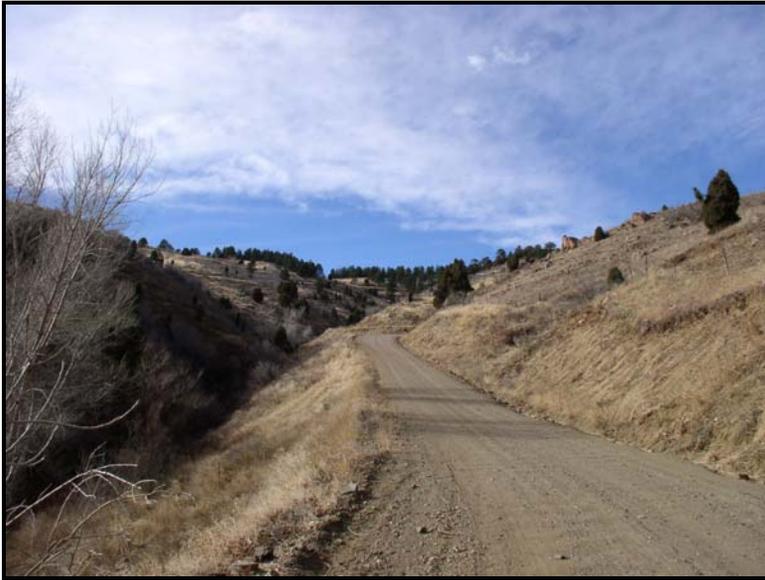
Figure 15

<b>Hazard Rating:</b>	<b>High</b>
<b>Does the neighborhood have dual access roads?</b>	No
<b>Are there road grades <math>\geq 10\%</math>?</b>	Yes
<b>Are all access roads of adequate width?</b>	No
<b>Average lot size:</b>	>5 Acre
<b>Fuel models found in the neighborhood:</b>	1, 2
<b>Water supply:</b>	2,000 gal. cistern at 22441 Golden Gate Canyon Road
<b>Hazards:</b>	Inadequate water supply, low power line

This community has moderate fuel loads of mostly short grasses (FM 1). Homes in this area are primarily newer construction types on large lots. Most are located on the tops of ridges and defensible space could be improved by mowing grasses away from structures. Many homes have steep, narrow driveways with poor turnarounds for trucks. Addressing is poor or missing throughout the area. There is a low power line at 245 Bear Road that may be a problem for larger apparatus.

Mow around structures. Improve address signage. Driveway improvements and turnarounds are recommended. Individual cisterns or two or three large (10,000 to 30,000 gallon) community cisterns are recommended. A parcel level analysis of this neighborhood is recommended.

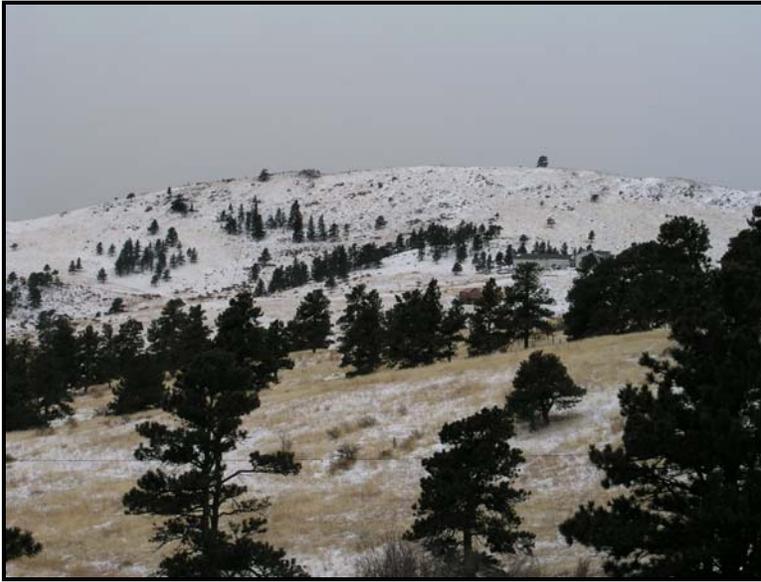
Figure 16

<b>Hazard Rating:</b>	Moderate
<b>Does the neighborhood have dual access roads?</b>	Yes
<b>Are there road grades <math>\geq 10\%</math>?</b>	Yes
<b>Are all access roads of adequate width?</b>	Yes
<b>Average lot size:</b>	>5 Acres
<b>Fuel models found in the neighborhood:</b>	1, 2
<b>Water supply:</b>	Cistern on Guy Hill Road and ponds on Golden Gate Road
<b>Hazards:</b>	Ravines, equipment parked in driveways, gasoline tanks

This area is very similar to Horseradish Gulch, but the terrain is not as steep and fuels loads are lighter. The only three homes here are older construction types on large lots. Homes have ignition resistant roofs with wooden exterior walls. Roads and driveways are steep in spots, but most are of adequate width. One residence has equipment partially blocking the driveway and there are gasoline tanks on at least one property. Fuels are predominately FM 1 and some FM 2 in the lower canyon where residences are concentrated. The terrain becomes steeper at the upper end of the canyon and there is a greater density of shrub fuels. There are communication towers, located at 5318 Rye Gulch Road, built on the top of the ridge. A secondary access connects Rye Gulch Road with Guy Hill Road but this is rough and may require 4WD.

Move equipment from driveways and locate gasoline tanks away from structures. Mow grasses away from structures. All homes need reflective addressing. Improve the secondary access to Guy Hill Road.

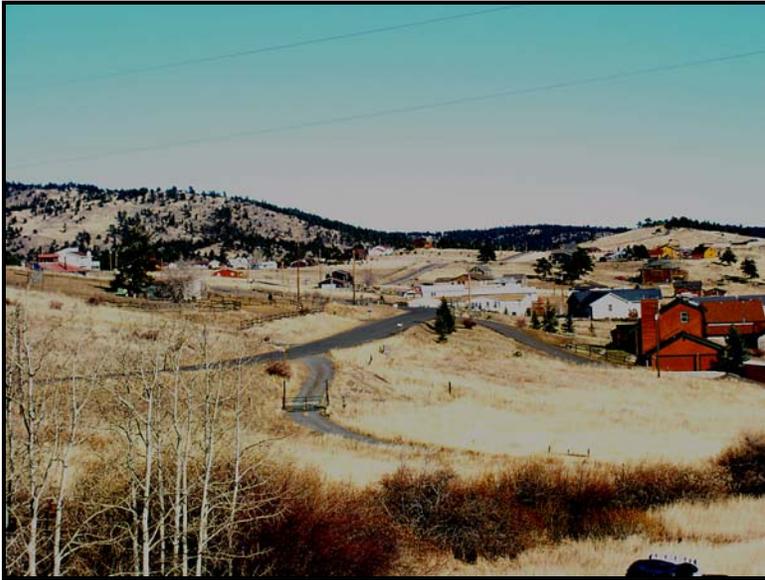
**Figure 17**

<b>Hazard Rating:</b>	<b>Low</b>
<b>Does the neighborhood have dual access roads?</b>	Yes
<b>Are there road grades <math>\geq 10\%</math>?</b>	Yes
<b>Are all access roads of adequate width?</b>	Yes
<b>Average lot size:</b>	>5 Acres
<b>Fuel models found in the neighborhood:</b>	1, 2
<b>Water supply:</b>	Ponds, tanks and cisterns.
<b>Hazards:</b>	Ravines

The only fire station in GGFPD is in this community. Homes are primarily newer construction types. Most have wooden external walls with ignition resistant roofs. The dominant fuel model is short grass (FM 1) with some FM 2 on north and west facing slopes. Most homes have good defensible spaces and visible addressing. Plentiful water, proximity to the fire station, mostly flat terrain and light fuels combine to make this a low hazard community. Problem areas would include the few homes located up steep driveways off the steep portion of Robinson Hill Road and homes along Calle Louisa that are located above steep slopes.

Thin slopes below homes on Calle Louisa and along the steep driveways off the eastern portion of Robinson Hill Road. Extended defensible spaces for homes above steep slopes. Mow grasses away from structures and add address markers for homes that do not have them.

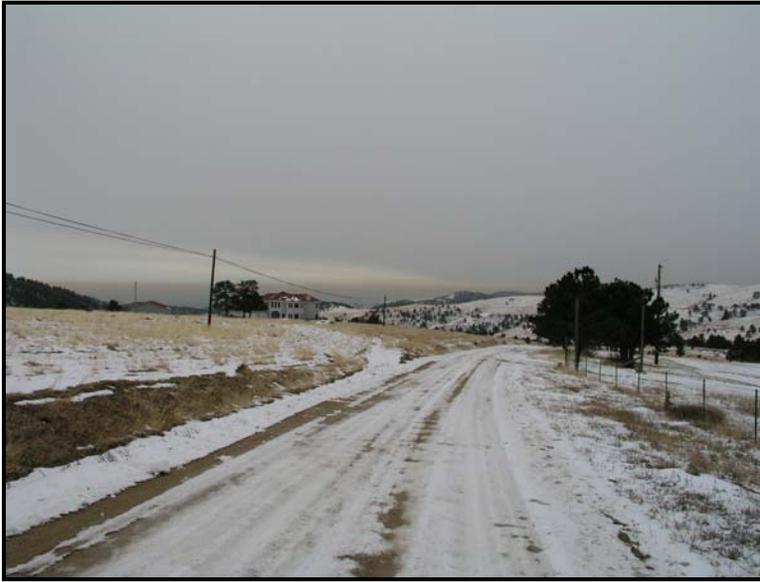
Figure 18

<b>Hazard Rating:</b>	Low
<b>Does the neighborhood have dual access roads?</b>	No
<b>Are there road grades <math>\geq 10\%</math>?</b>	No
<b>Are all access roads of adequate width?</b>	Yes
<b>Average lot size:</b>	>5 Acre
<b>Fuel models found in the neighborhood:</b>	1, 2
<b>Water supply:</b>	Dry hydrants
<b>Hazards:</b>	Ravines

This area has moderate to light loads of primarily FM 1. Homes are primarily new construction on large lots. Most structures are built on flat or gently rolling terrain on the tops of broad ridges. Some homes in the Daydream Road area have ravines of up to 22% slope below structures, but fuels are still light to moderate loads of FM 1 and FM 2. North of the residences on the north side of Golden Gate Road, Guy Hill Road becomes narrow and passes through some heavier fuels, but this area appears to be uninhabited.

Some homes need reflective address markers and grasses mowed away from foundations. Fuels should be thinned on both sides of the narrow portion of Guy Hill Road to make it a more viable access/egress route.

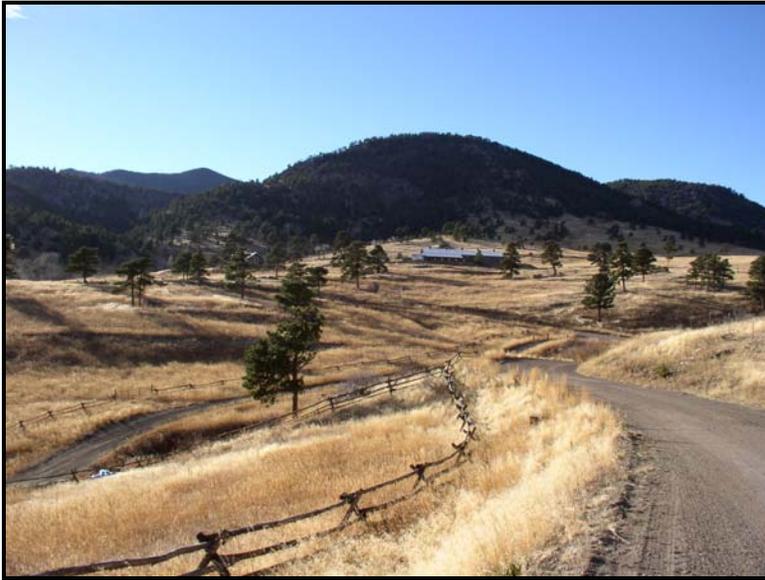
**Figure 19**

<b>Hazard Rating:</b>	<b>Low</b>
<b>Does the neighborhood have dual access roads?</b>	Yes
<b>Are there road grades <math>\geq 10\%</math>?</b>	No
<b>Are all access roads of adequate width?</b>	Yes
<b>Average lot size:</b>	>5 Acres
<b>Fuel models found in the neighborhood:</b>	1, 2, 10
<b>Water supply:</b>	Many draft ponds
<b>Hazards:</b>	Ravines

This neighborhood has light to moderate loads of mostly FM 1 and FM 2. Slopes near most of the homes in this community are generally less than 15%. The upper (western) area is steeper (up to 30% slope) and has a higher fuel load (FM 10), but there are few homes here and the access is good. This community is comprised of primarily well-built homes with ignition resistant roofs on large lots. There are a few historic, and very flammable, ranch buildings, but most are a significant distance from residences. There is a good water supply and access to structures is good. Most homes have good defensible space.

Most homes need reflective addressing. Some homes in the western end may need extended defensible space.
