RE: Grading and Drainage Conditions Review/Comments  
Golden Gate Canyon Fire Station #83  
25231 Golden Gate Canyon Rd, Golden, CO 80403  
Engineering Job No. E24-0122

The purpose of this letter is provide our professional opinion on drainage affecting this unmanned fire station at the above location, and recommend upgrades to prevent continual sediment nuisance conditions and periodic building flooding. We visited the site on Tuesday, June 18, 2024. The site is located off Golden Gate Canyon Road and consists if a two bay wood/metal framed garage structure with bathroom addition. There is a private shared driveway located on the west side of the building, along with a natural drainage between the private drive and the building from the valley above. The hillside behind the building is steep and has a private driveway serving a residence that cuts across behind the building approximately 200' uphill. Evidence of drainage from the property above enters onto the fire station property behind the structure, carrying sediment and debris, which deposits out in the parking area, behind and along the east side of the building, and periodically floods the building through the east side ac

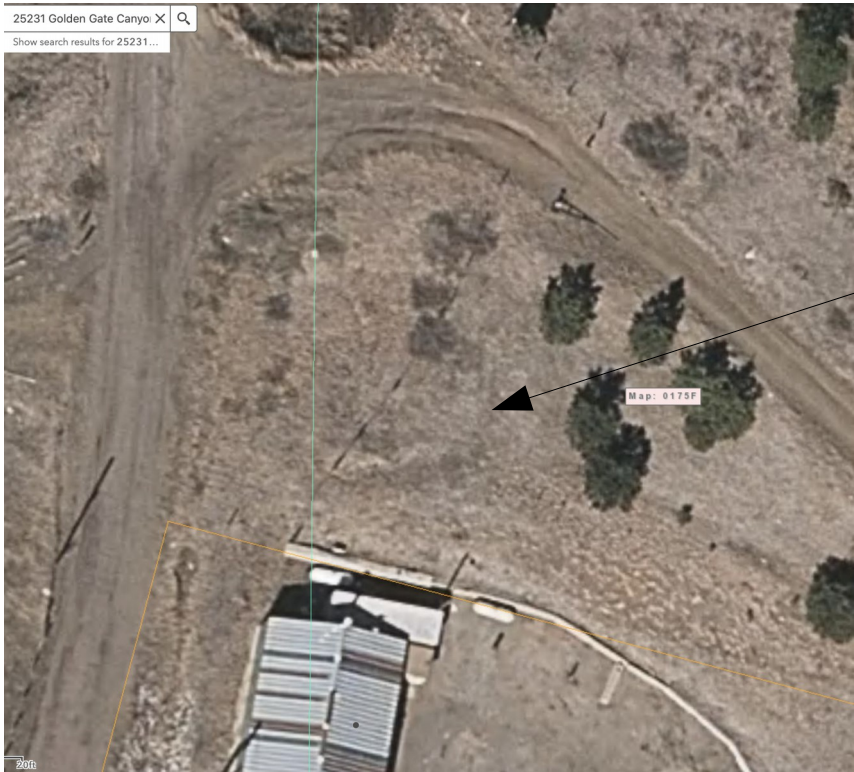
Image 1 – 2018 Jeffco GIS aerial image

1. Reviewing aerial imagery from both Jefferson County GIS and Google Earth Imagery, prior to 2018, the conditions reviewed were not present (**Reference Image 1**).

No evidence of erosion

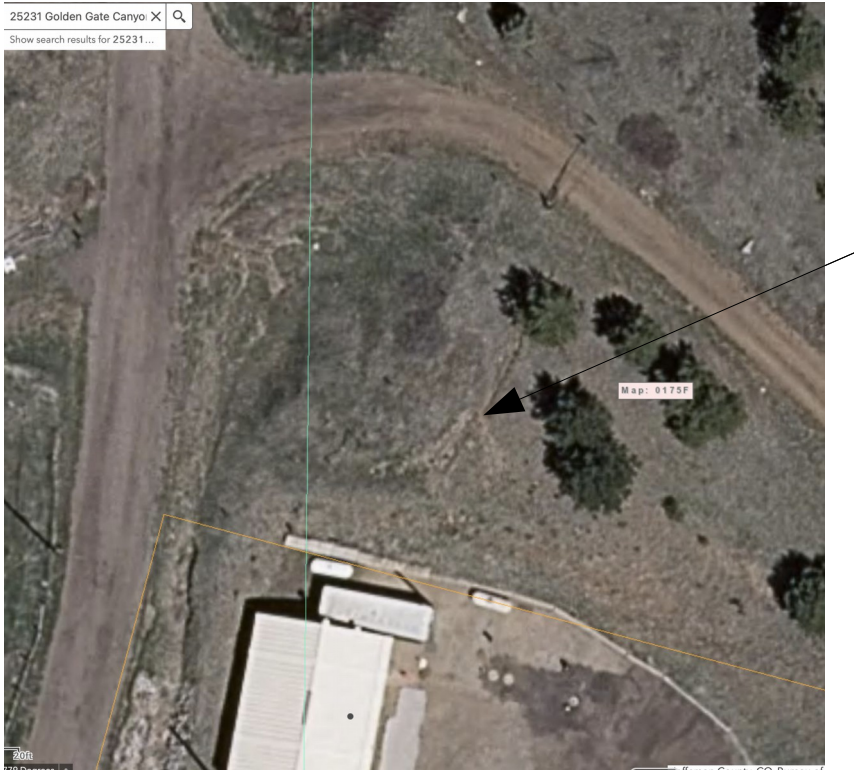
Image 2 – 2020 Jeffco GIS aerial image

2. After 2018, 2020 Jefferson County GIS imagery shows distinct erosion below the driveway above directly behind the fire station (**Reference Image 2**) and sediment contamination onto the fire department property (**Reference Image 3 & 4**).

3. Inspection of the driveway above the fire station revealed that a cross culvert was added under the driveway before the gate, which is conveying hillside drainage above the driveway, and driveway drainage under the driveway directly uphill behind the fire station which is creating these conditions reviewed. Reference video link: [https://www.dropbox.com/scl/fi/lercvf97bn1rbwvmhasom/20240618\\_Culvert-above.mp4?rlkey=5bnenkyvqz5dw9d5d30vevpec&dl=0](https://www.dropbox.com/scl/fi/lercvf97bn1rbwvmhasom/20240618_Culvert-above.mp4?rlkey=5bnenkyvqz5dw9d5d30vevpec&dl=0)

Evidence of erosion from driveway cross culvert above

1. The obvious and easiest correction is to have the property owner above remove the cross culvert that was installed, dumping all the drainage onto the slope below the driveway directly above and behind the fire station, and grade the roadside ditch past the gate to direct all drainage into the existing natural drainage collection system that parallels the private drive adjacent to the fire station. This corrects the problem of the added culvert and restores the historical drainage pattern.

2. Should this not be allowed due to property lines or other potential conflicts, the property owner above could be directed to install an armored rip-rap lined cut-off swale in the hillside above the fire station below the culvert point source discharge and graded to direct all flows to the west into the existing drainage collection system below the driveway, above the fire station before the drainage crosses onto fire department property. A design can be provided upon request. This would effectively allow the driveway cross culvert to remain, but correct the issues created from the errant drainage being directed directly into the back of the fire station property.

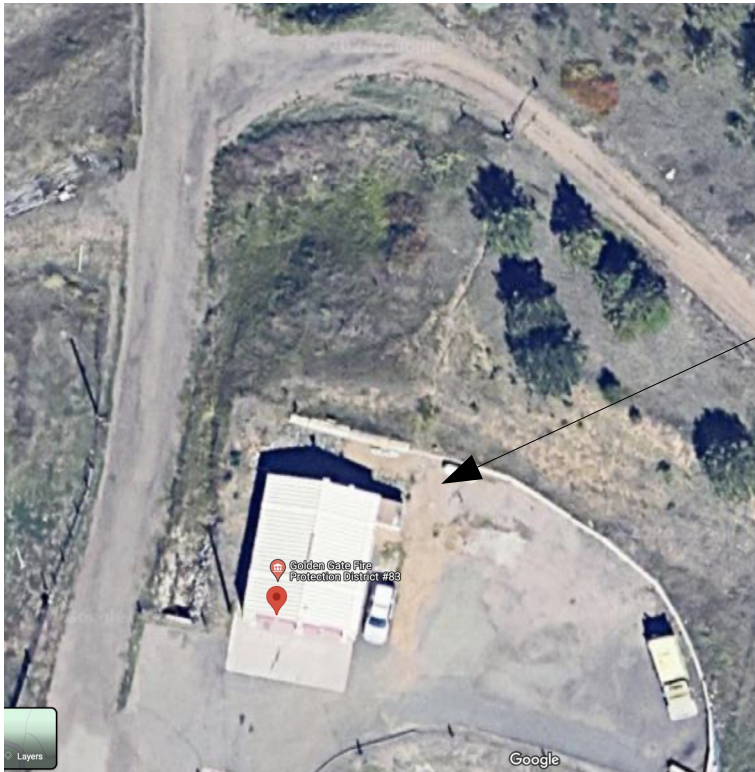
Image 3 – Google Earth Image showing sediment migration/deposition behind the fire station

Sediment deposition on station property

3. Alternative 3 to more immediately correct the drainage/sediment control problem on the fire station property while the above are being pursued through proper channels, would be to excavate and install a concrete drain pan below the existing retaining wall behind the building with perimeter curb to protect (the parking area and building), collect and direct all drainage to the west into the existing culvert to the existing drainage collections system on the west side of the station. A design can be provided upon request.
